VI International Workshop Structures in Fire
- Aveiro 2006 -

A REAL FIRE IN A SMALL APARTMENT – A CASE STUDY –

In January 2002, a fire started in the fourth floor apartment. The fire destroyed all living room furniture and covering. part of all inner masonry was demolished in the after fire due to small cracks and fissures The family who slept in the bedrooms was saved, but had risk of dead by smoke of a child.

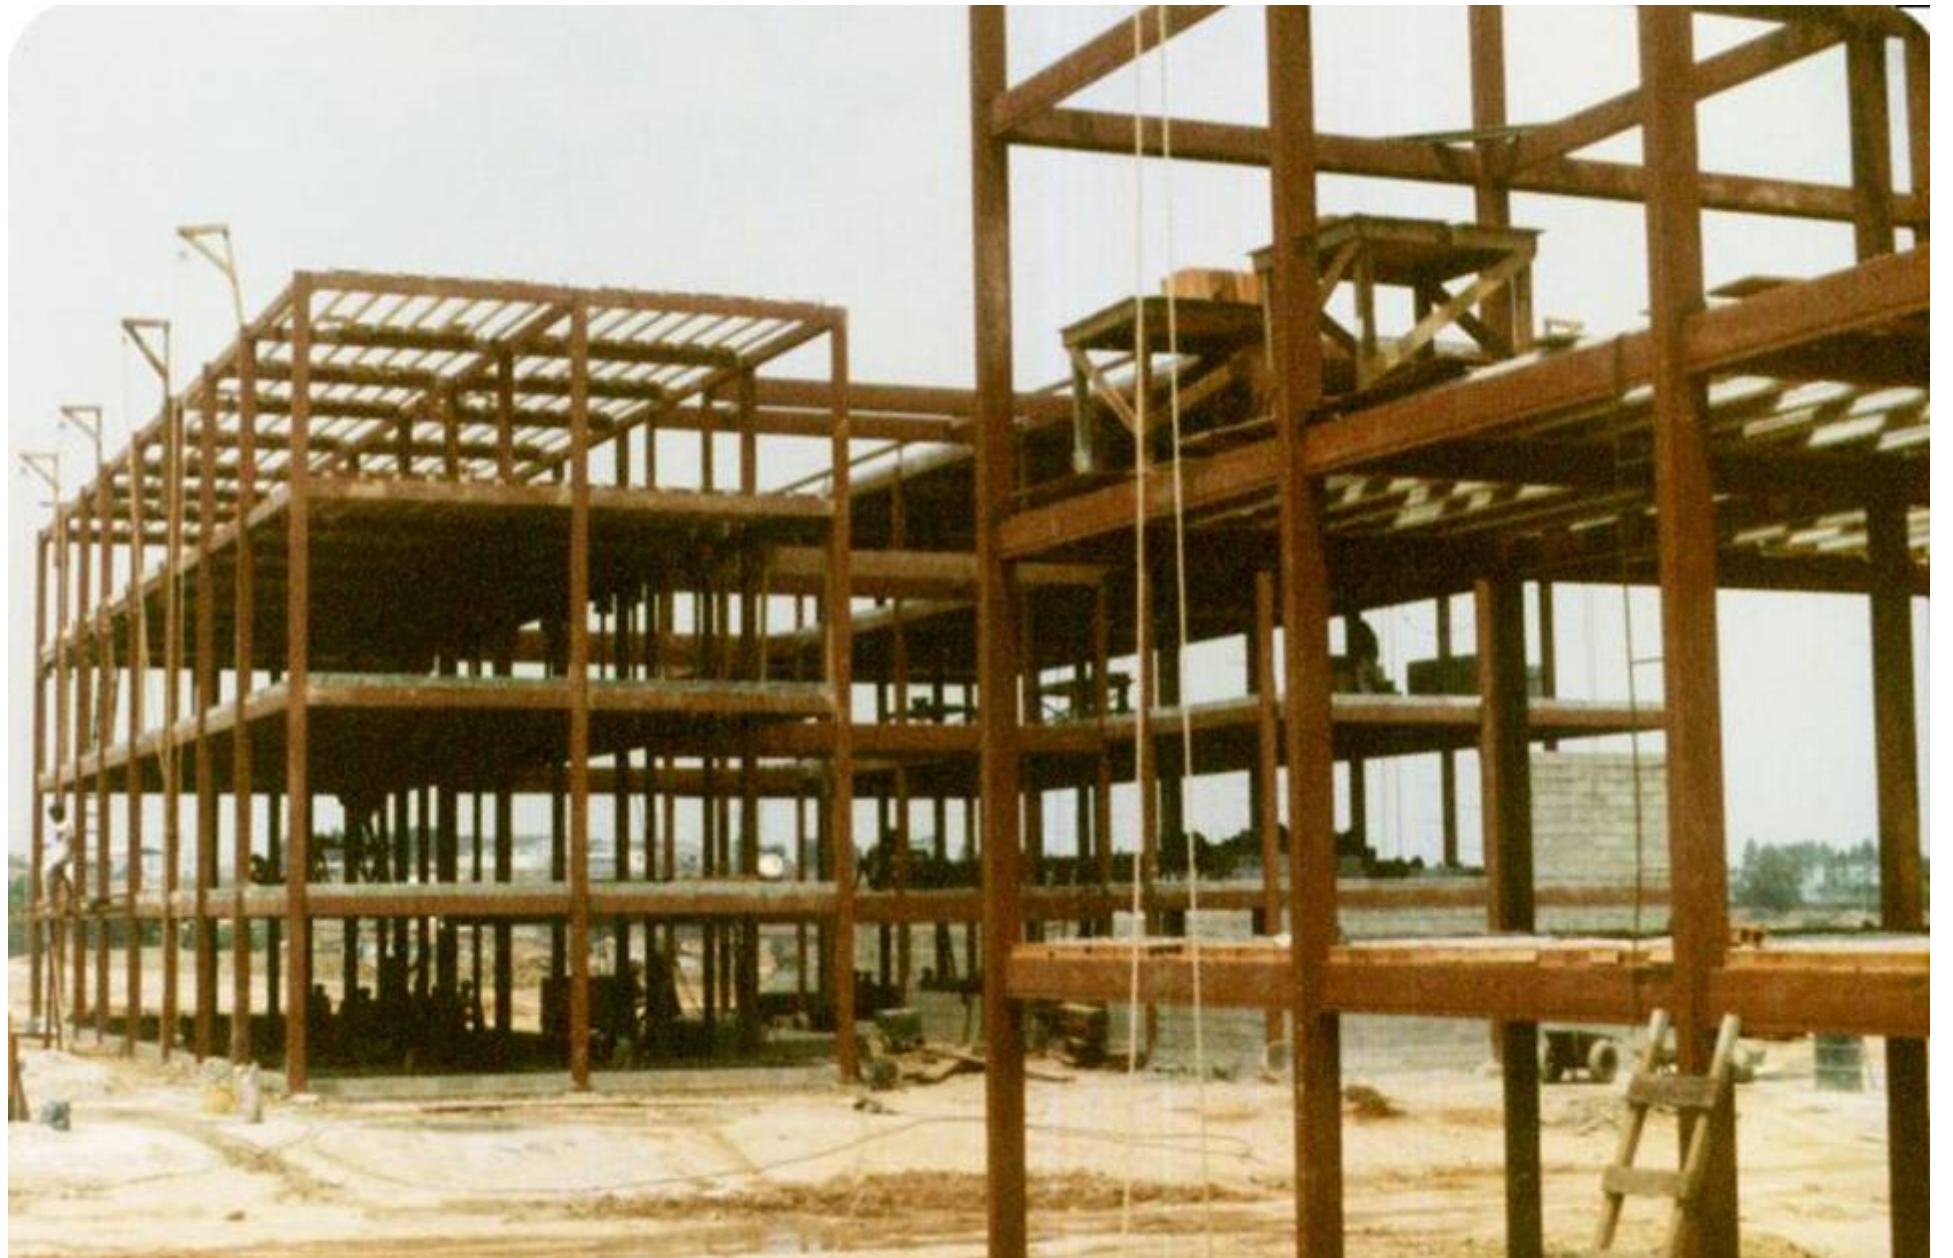
The structure is cold formed steel

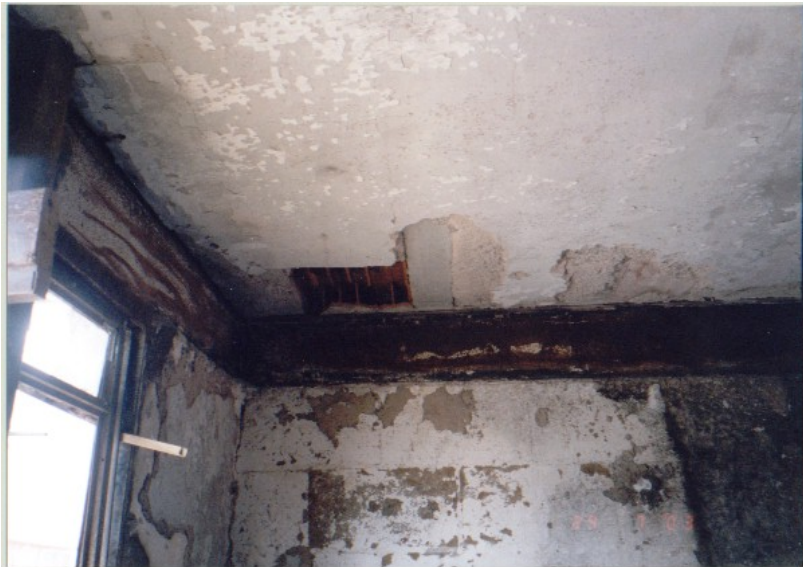
The composite slab started to degrade just close were the fire initiated

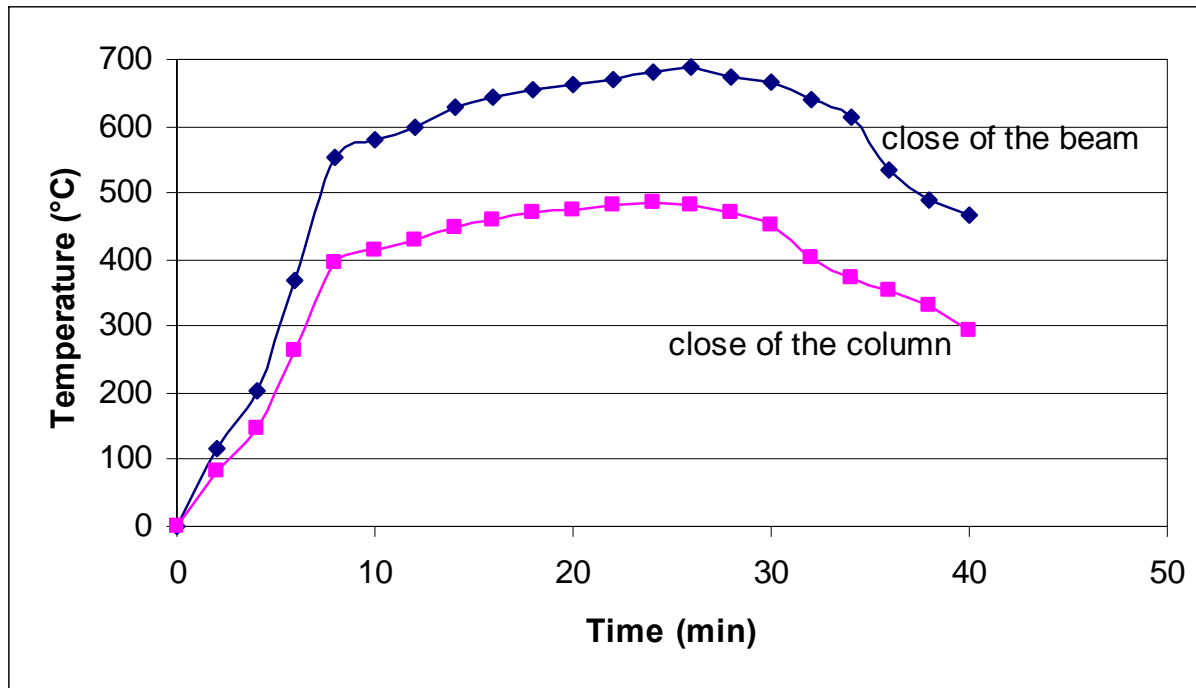
temperature of the hot gases
close of the beam and column

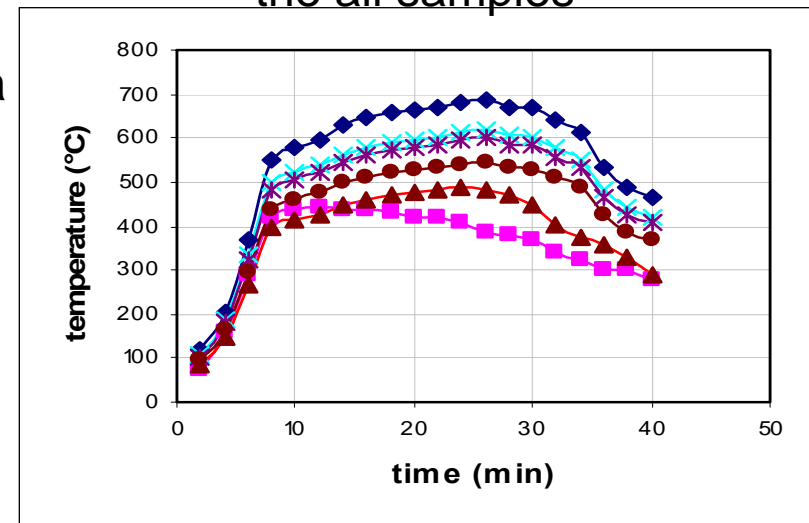
temperature of the gases close of
the all samples

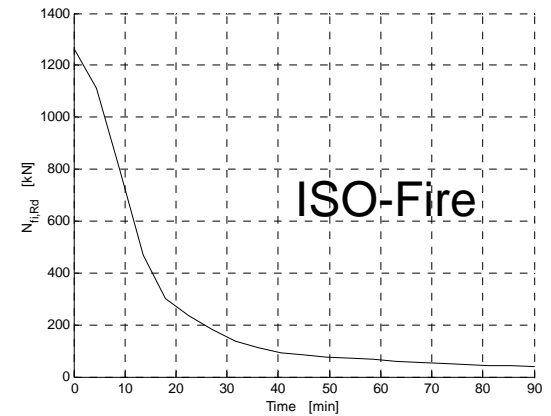
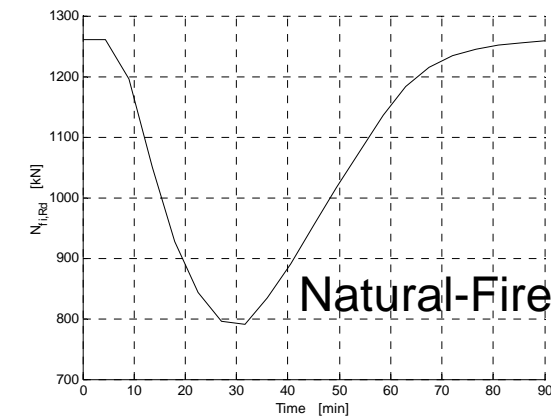
Resistance for uniform
compression vs. time
on the column with wall

Column
 θ (equivalent) ≤ 400 °C

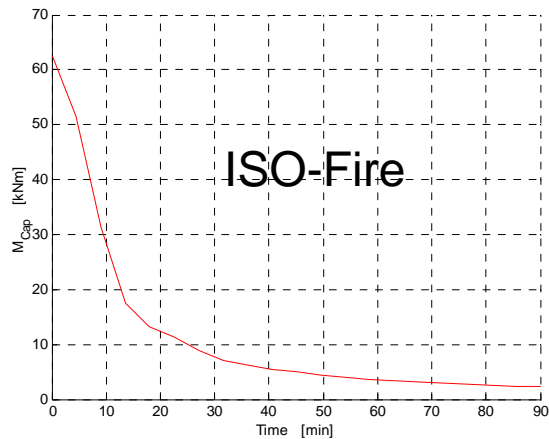
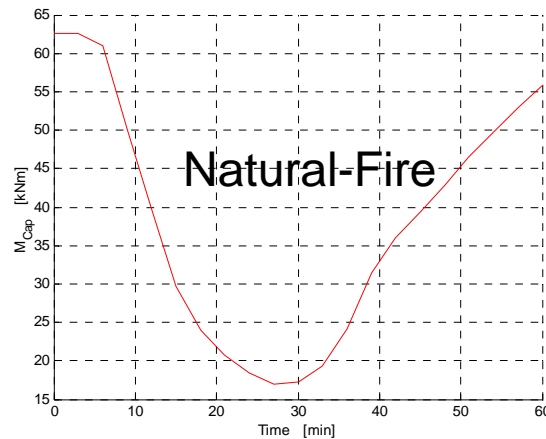
Beam
 θ (equivalent) ≤ 610 °C

Resistance for bending moment vs. time on the beam under a slab $M_{fi,Rd} = W_{pl} f_y k_{y,\theta}$
